# CAUSAL ANALYSIS ON HERALD OF FREE ENTERPRISE'S DISASTER: A STAMP-BASED APPROACH

**Amina Hassan Abubakar** Department of Computer Science,  
Faculty of Physical Sciences,  
Ahmadu Bello University, Zaria.

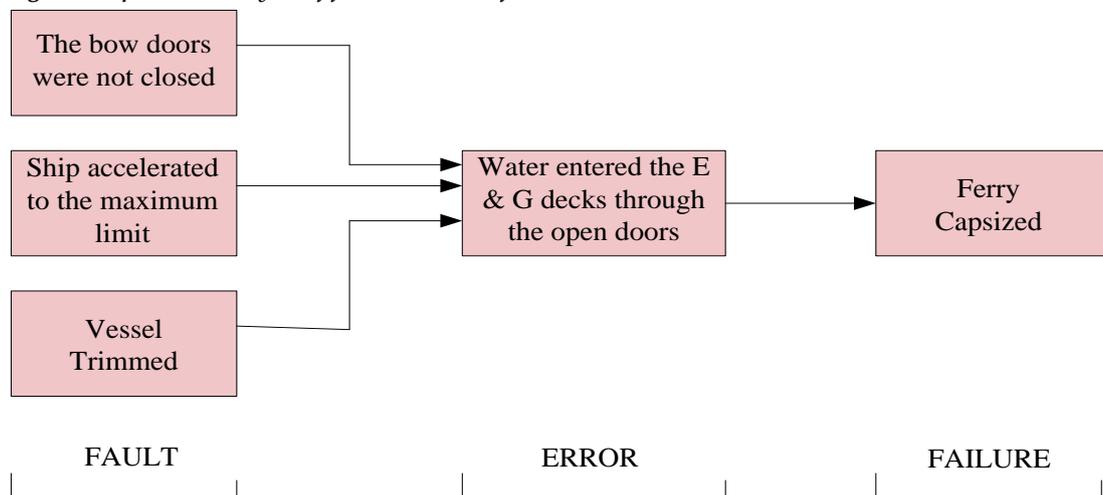
Figure 1: Fault - Error - Failure Analysis

**FAULT 1:** *The Assistant Boatswain failed to close the bow doors*

This resulted in water entering the ship through the opened doors in very large quantity; thereby causing flooding of the car deck and causing instability of the ferry.

**FAULT2:** *The vessel was trimmed*

**FAULT3:** *Normal Control procedure was not followed, hence, the ship accelerate rapidly*

Figure 1 depict the analysis of fault, error and failure.

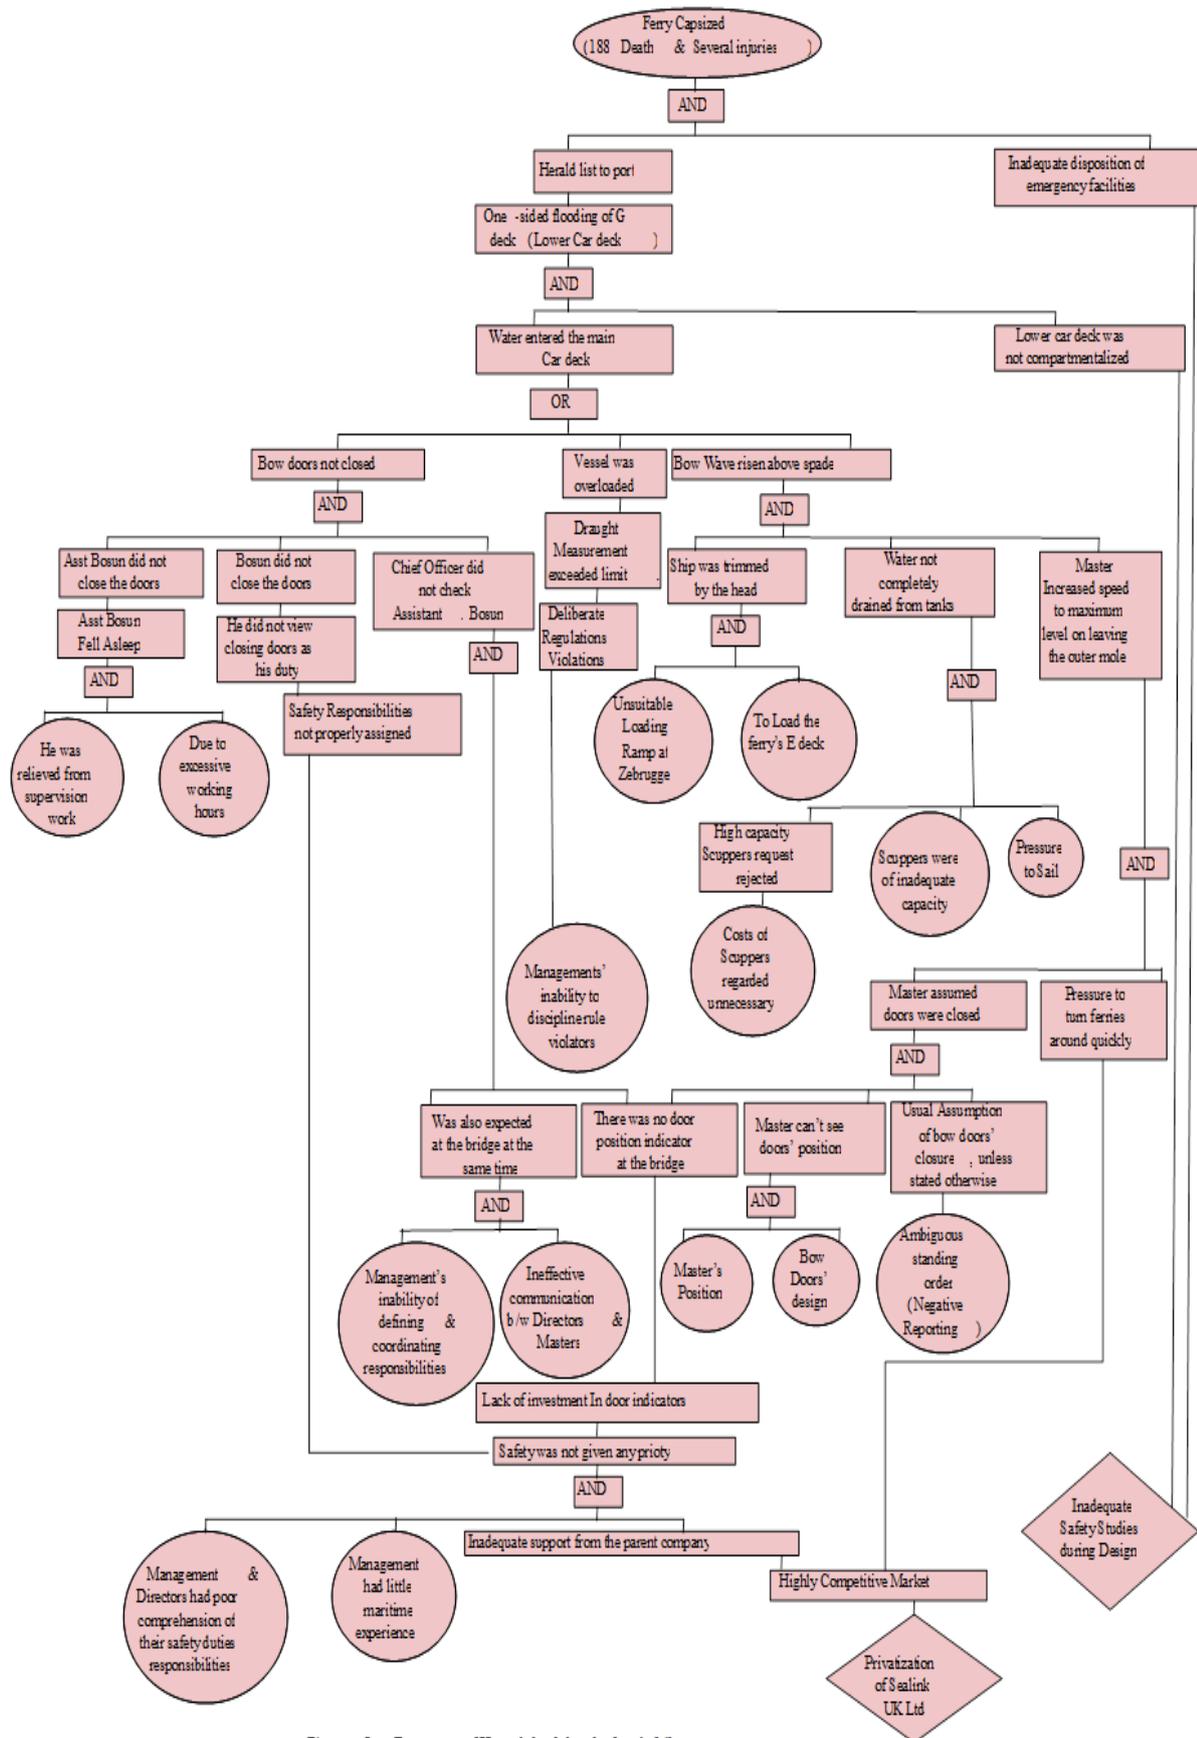
Figure 3: Root Causes of Hazard that led to the ferry's failure

**(i) The Performance of the operator:** The Assistant Bosun slept while he supposed to be at his duty, because the crews were subjected to physical and mental stress as a result of excessive working hours.

**(vi) Engineering Integrity:** There was nothing to indicate the position of the bow doors to those at the bridge. Likewise the RORO ferries were inherently instable due to their design flaws because the lower deck was not divided to prevent water from moving freely.

**(x) The external systems:** Lack of support from the parent company to the senior staffs was also contributing factor to the failure of the ferry, the company was more interested in profit than safety of its staffs and passengers. Figure 3 shows root causes of the Hazard that led to the ferry's failure.
